MINEVILLE, NEW YORK: A CONCRETE INDUSTRIAL VILLAGE
IN THE HEART OF THE ADIRONDACK FORESTS

A THESIS

The Graduate Program in Historic Preservation

1990

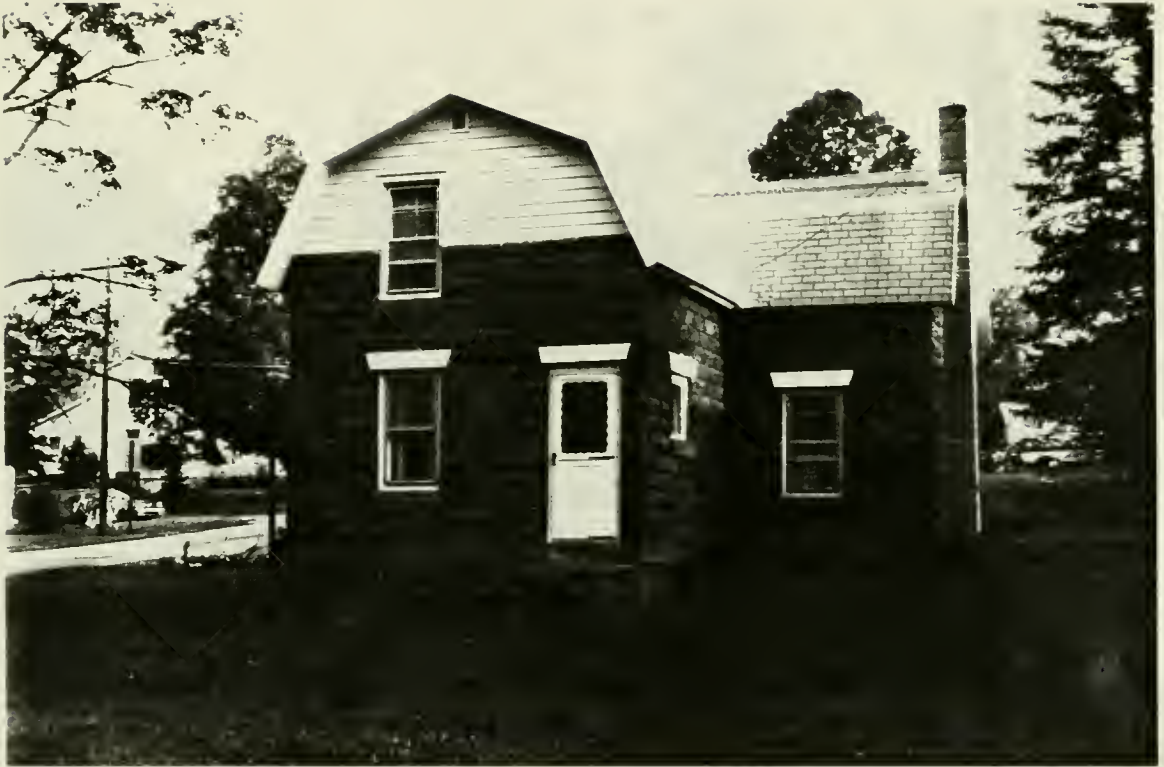
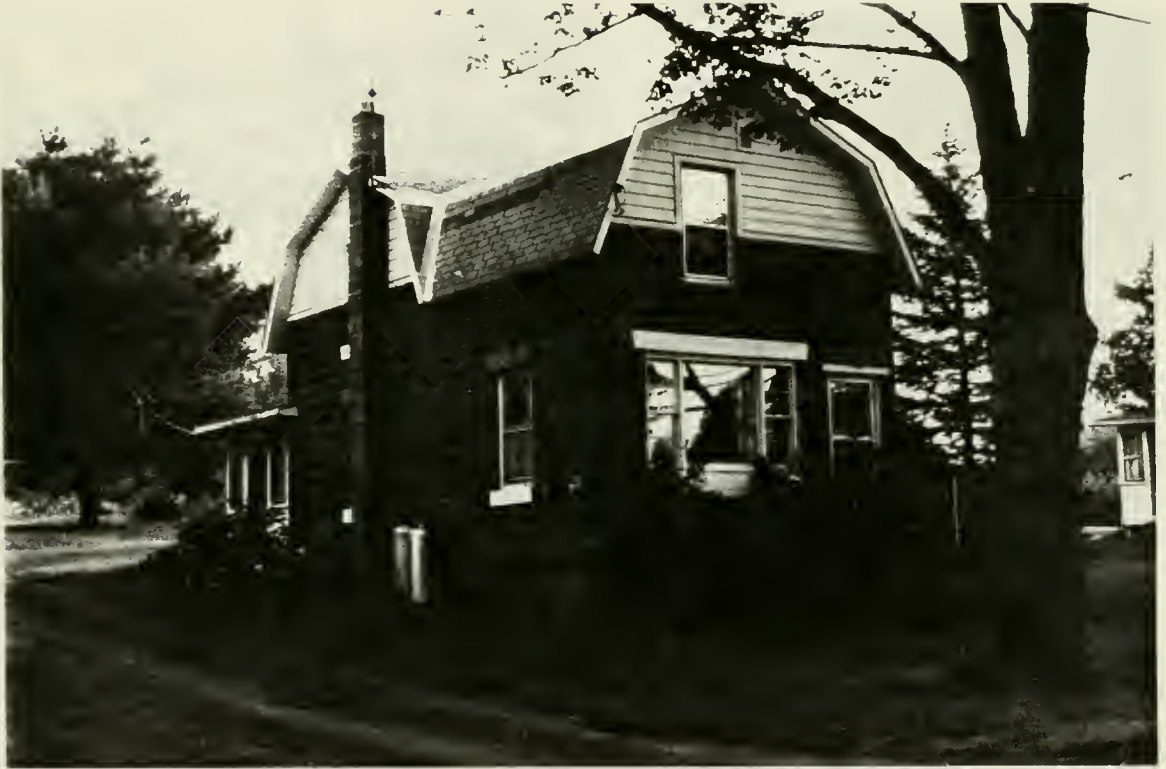
The Type One houses along Foote Street lack projecting string courses, and are difficult to inspect due to the prevalence of paint coatings. It is significant to note that even where the tailings block remains unpainted, the projecting lintels and keystones have often been painted white, as at 472 and 474 Joyce Road (See Fig.'s 23 & 24). Like the siding over deteriorated gable blocks, the

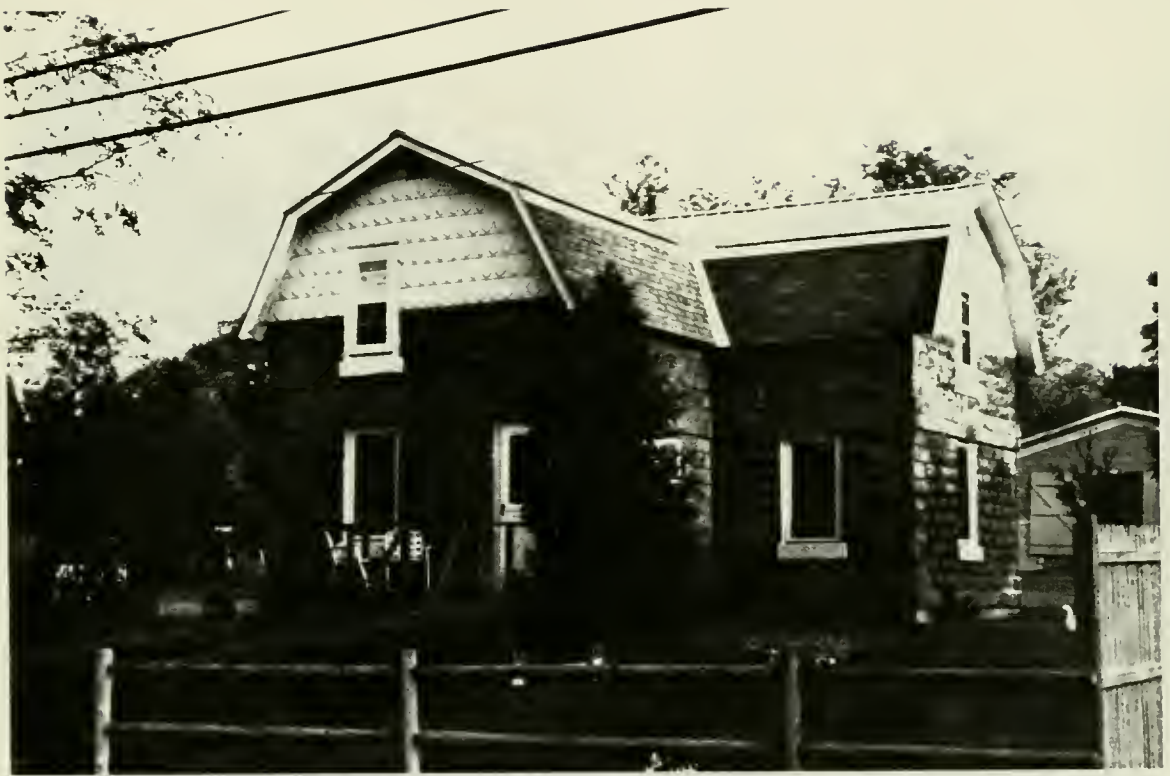
Figure 27

For the most part, projecting sill courses at ground level, and projecting string courses between first and second floors, are in excellent condition, with no evidence of displacement, few open joints, and little cracking. The projecting string course above the first floor at 482 Joyce Street does display horizontal cracking, and on closer examination, reveals a lack of vertical joints between smooth-faced blocks. To distinguish the surface texture and rhythm of the projecting string course from the coursed block above and below, the original builders used a smooth-faced block which was then coated with stucco, creating the illusion of a monolithic masonry band. The visible cracking in this string course at the east

elevation of No. 482 Joyce has developed as the very thin stucco skim coat has begun to fail, separating from the smooth-faced block substrate. This deterioration has gradually progressed, after years of differential shrinkage and expansion of coating and substrate during freeze-thaw cycles (See Fig. 28). The same failure mechanism has occurred at 474 Joyce Street, where the stucco skim coat has delaminated from a second story window sill, revealing the two smooth-faced blocks underneath (See Fig. 71). This same house displays one open joint in the stucco-coated block sill course (See Fig. 24). Although the thin stucco veneer over smooth-faced block, which did not allow for thermal movement of the substrate, has failed in several locations, the tailings block itself is in excellent condition. Only one sizable area loss was noted in decorative or projecting tailings block, at 480 Joyce Street, in the string course just to the left and above the entrance door (See Fig. 27).

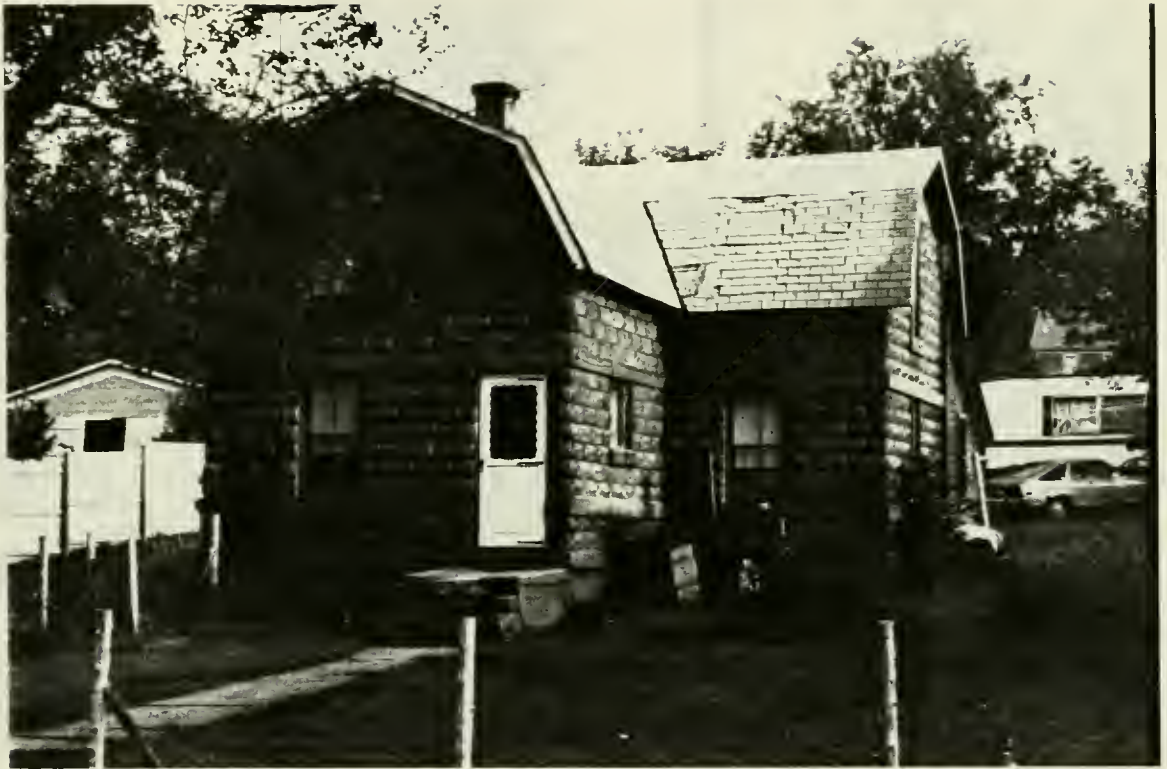
Figure 28

In general, the tailings block houses are in good condition. However, certain types of deterioration have occurred within each of the six house types. The Type One houses are generally in very good condition, in part because of their small size, the simplicity of their design, and their lack of projecting decoration. No settlement cracking is visible in any of the Joyce Road houses, except in the "monolithic" concrete entrance steps (See Fig. 28).

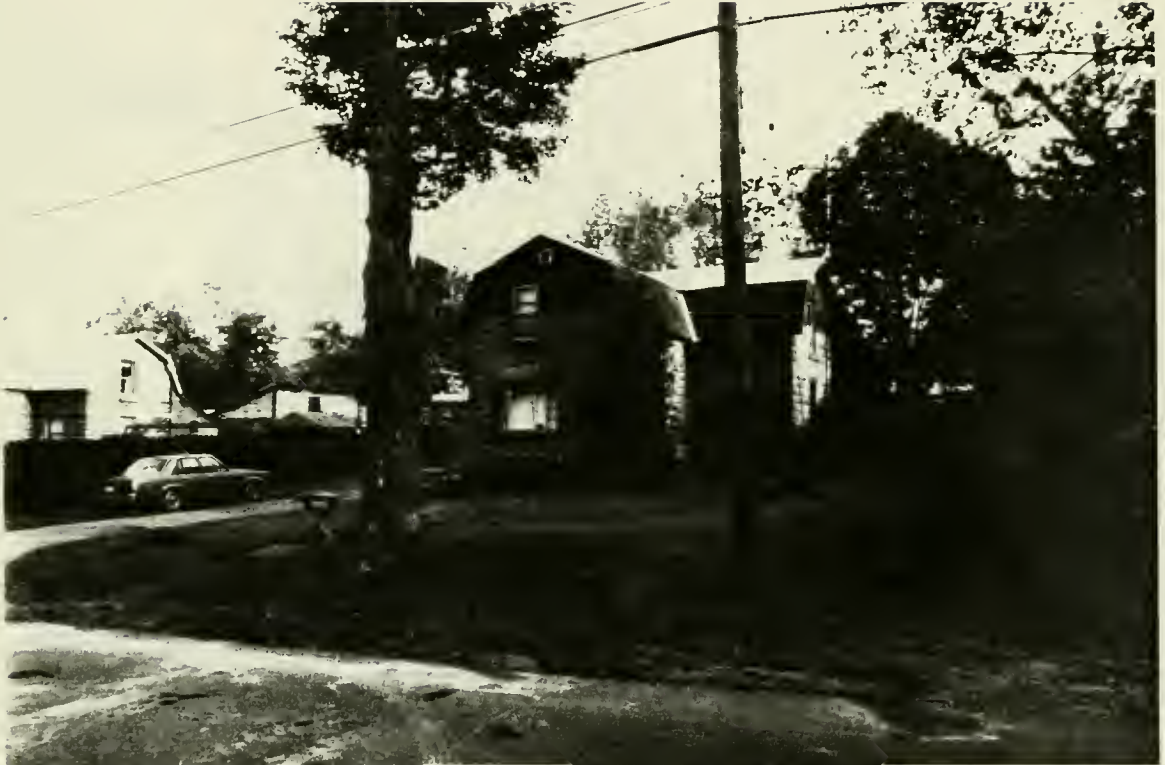
Figure 29

texture of the rough-faced block below. Owners then covered up the uneven block at upper gables with wood siding. In some cases, no siding was used, but the gable peak was painted, as at 484 Joyce (See Fig. 29). In the case of 405 Foote Street, a Type Three house, stucco was applied directly to smooth-faced tailings block, and immediately failed (See Fig. 70). Vertical board siding was added to cover the stucco (See Fig. 33).

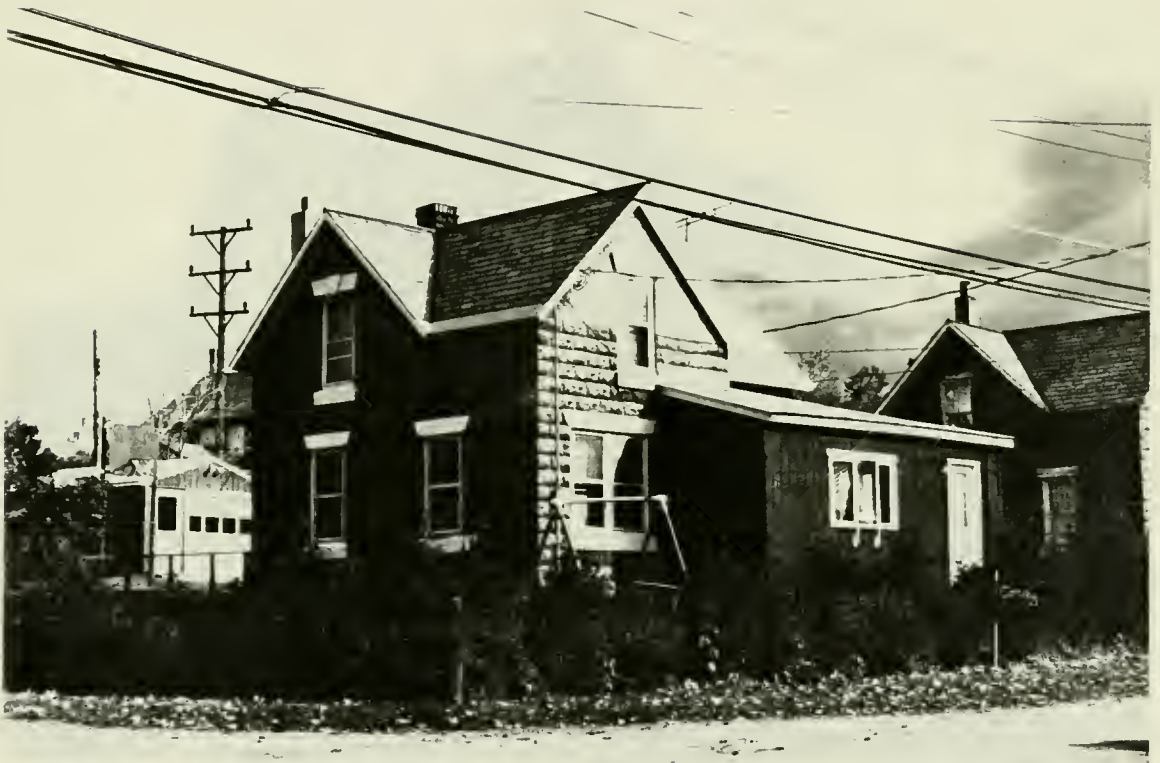
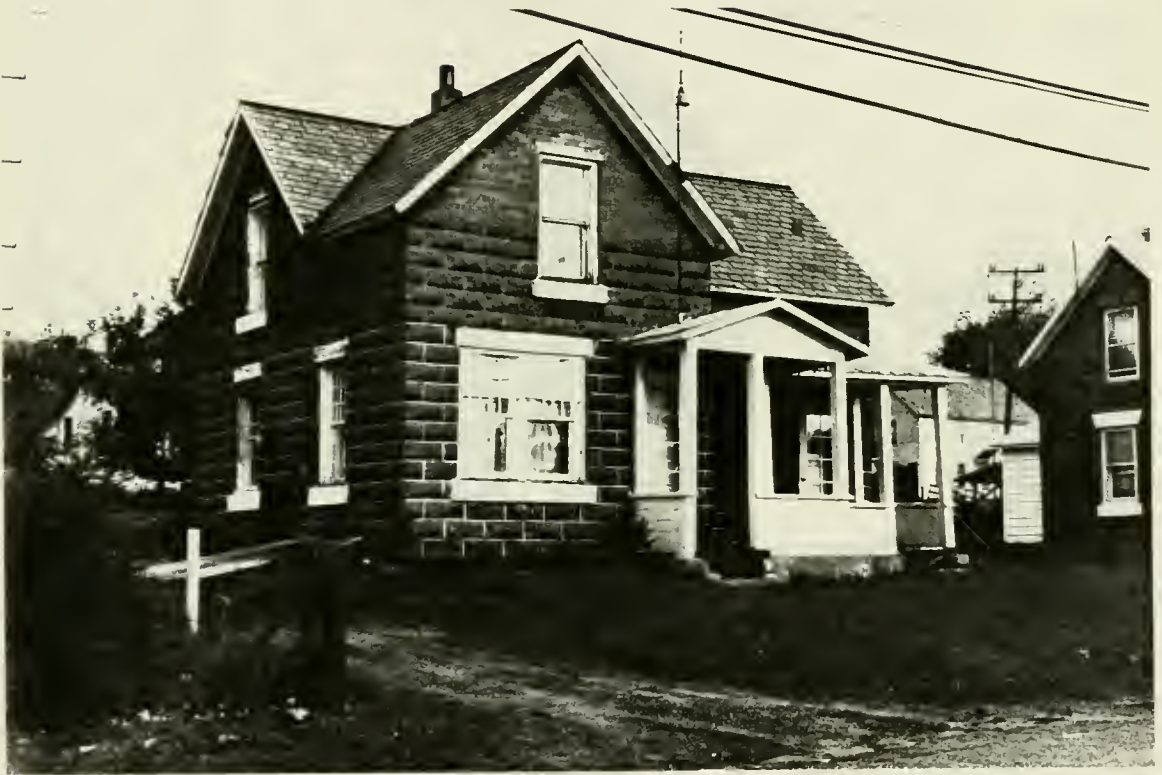
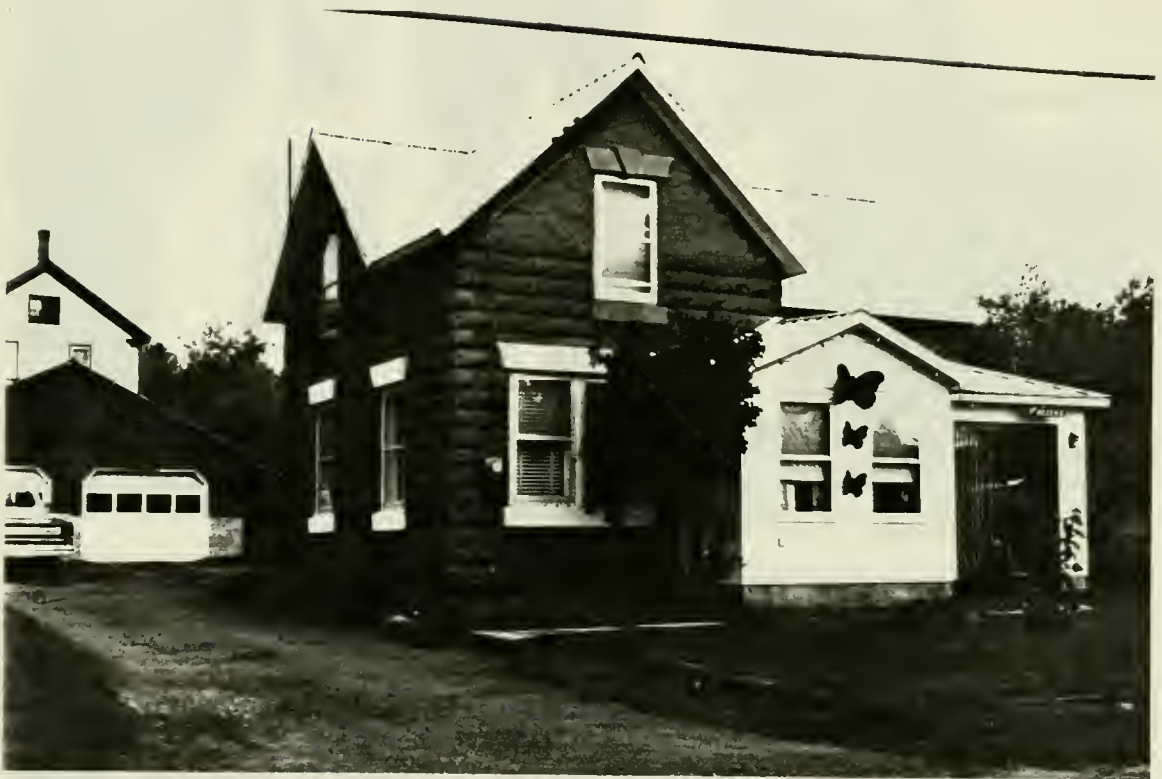
tailings concrete slab porches have been largely replaced as they were filled in to create additional rooms. The original porches were built directly on the ground, with no damp-proof course and no ventilation. As a result of this practice, the highly decorative porch of No. 509 Plank Road deteriorated rapidly and was removed by the mining company for the present owners in the late 1940's.³⁴ Other porches undoubtedly underwent similar deterioration, leaving occupants with no incentive to preserve the original porch configurations. The poor design detailing of the porches, combined with the difficulty in adding to the tailings block houses through exterior masonry walls, has led to their redesign and enclosure (See Fig.'s 30-33).
